ICOMOS/IUCN Advisory Mission to Ngorongoro Conservation Area  
(United Republic of Tanzania)

23<sup>rd</sup> to 26<sup>th</sup> August 2017

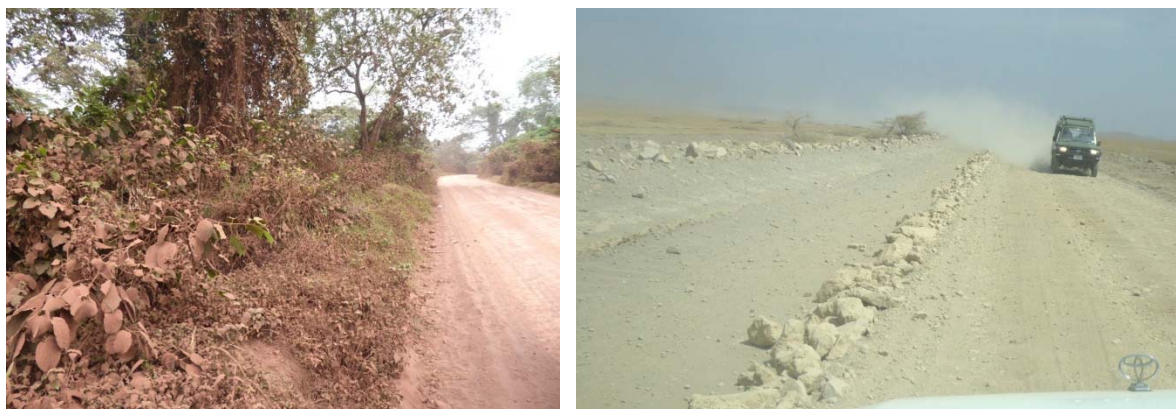
As noted above the existing main road through Ngorongoro is a murram/gravel road maintained by NCAA. It has a nominal width of 7m, but in practice its 'footprint' includes an equivalent width on each verge, where waste material, drainage ditches, erosion and vegetation cloaked in road dust are

significant local impacts. Maintenance of this road is expensive: the NCAA spent the equivalent of between US\$1.4 m and US\$3.6 m annually on road maintenance over the period 2009-2013, funds that might otherwise have been used on other urgent protection and conservation works. In addition to the financial burden of road maintenance, NCAA suffers a chronic shortage of suitable construction materials for maintenance. Materials from within the NCA are preferred as this prevents the inadvertent importation (and subsequent spread) of invasive alien plants. However the suitability and quality of materials available within the NCA is low, so substandard materials are used, maintenance has to be carried out more frequently than should be necessary, and the large quantity of material required creates excessively large borrow pits and associated environmental impacts.

**Fig. 3.** Existing road conditions. Roadside vegetation is cloaked in a heavy coat of unsightly dust (left); the width of the road crossing the plains near Golini is considerably greater than the carriageway itself due to waste material piled along the road verges (right). ©IUCN/Peter Howard.

**R8.** As an interim measure prior to surface hardening NCAA should review the method of maintenance of the existing unpaved road, particularly in the section across the plains from +43.000 to Golini Gate. The review should include options such as enforcement of the speed limit of 50 km/h to reduce degradation, inclusion of geocell reinforcement to increase longevity of the gravel surface and management of the (unsightly) waste material at the road-side, not used within the surfacing.

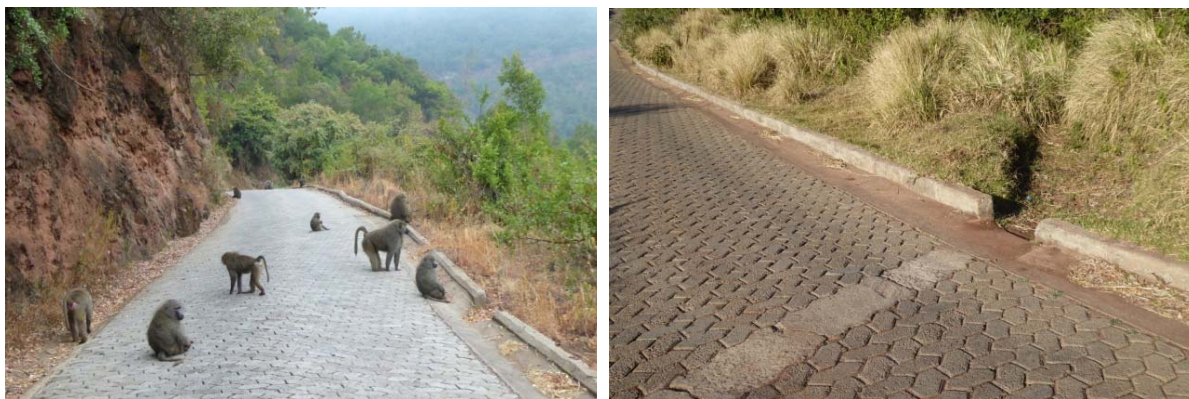
The 5km-long ‘crater ascent road’ is a steep one-way road which is used by about 300 tourist vehicles daily. Over a period of about three years (2009-12) this road was resurfaced using interlocking concrete paving blocks, providing valuable experience of road hardening within the NCA and serving as a useful ‘pilot project’. The outcome is considered highly successful. The road has required no maintenance over its first five years of service, whilst providing a comfortable ride for visitors at the end of a long day, and has blended well into the landscape as natural vegetation has become re-established right up to the road edge and the textured concrete surface has trapped soil and ‘weathered in’. The ‘footprint’ of this road is significantly smaller than it would have been prior to its re-surfacing.

**Fig. 4.** The crater ascent road was re-surfaced about five years ago with interlocking concrete blocks. This has been highly successful and reduced the width of the road 'footprint' considerably as vegetation is established right up to the kerb. ©IUCN/Peter Howard.

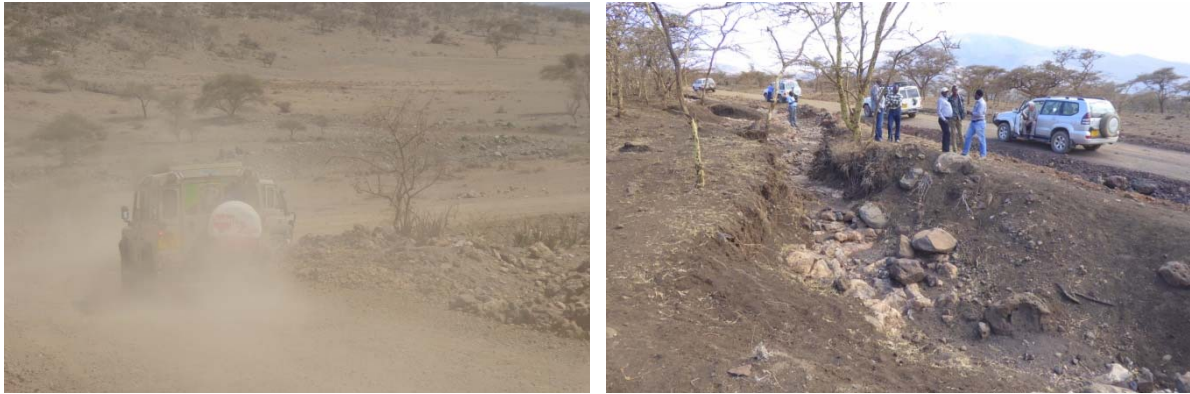
**Fig.5.** The experience of visitors travelling the present dirt road is characterized by an abundance of dust, discomfort and unsightly road verges piled with waste rock and scarred with erosion gulleys. ©IUCN/Peter Howard.

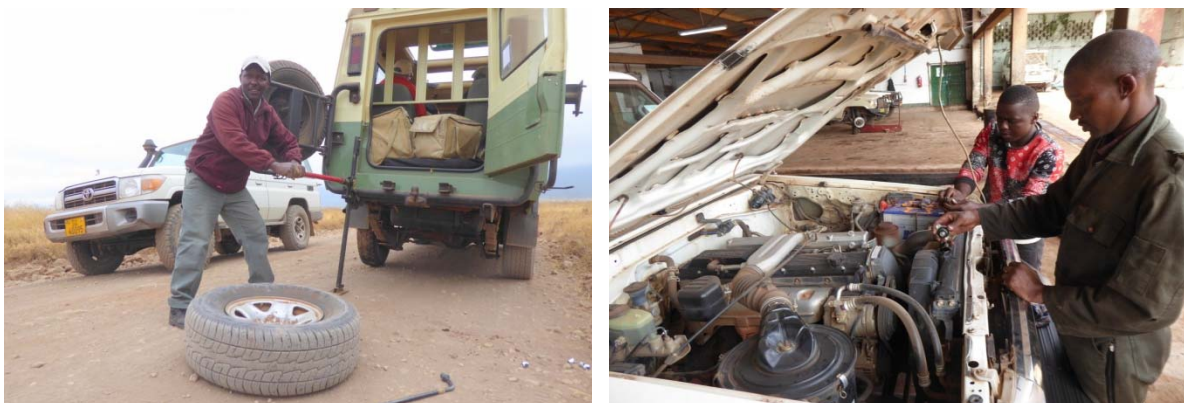
The present condition of the road results in high vehicle maintenance costs for all road users, and is of particular concern to tour operators and NCAA. In some cases, major tour operators consider it necessary to maintain ‘standby vehicles’ because of the high incidence of breakdowns. A surfaced road is expected to contribute to reduced vehicle maintenance costs and corresponding increase in operational efficiency for the tourism sector and NCAA management.

**Fig.6.** Existing road conditions cause frequent breakdowns, roadside tyre changes and high vehicle maintenance costs. ©IUCN/Peter Howard.

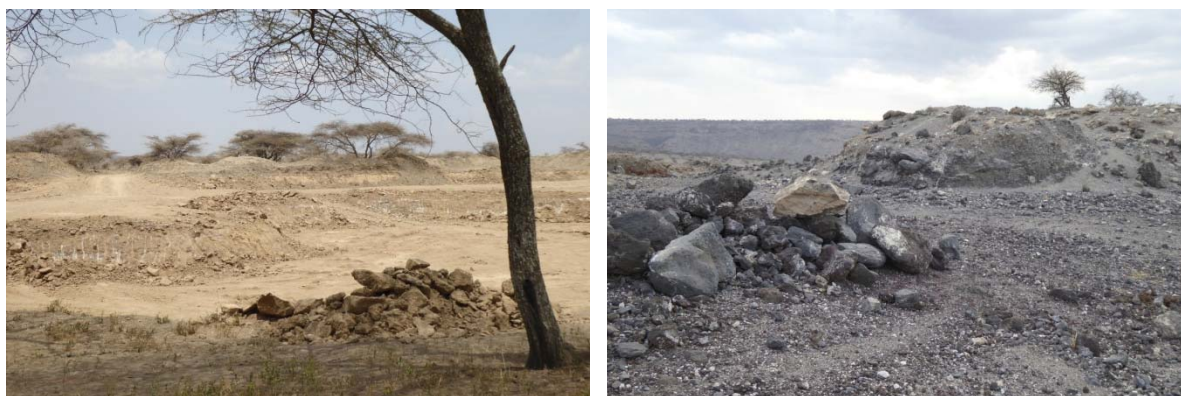
The project has been designed to make use of locally-available materials, thereby reducing the risk of inadvertently introducing invasive alien plants from outside the NCA. This means that considerable quantities of stone and related materials will need to be quarried within the NCA and large quantities of water (a scarce commodity) will be required, especially for concrete production and curing. Careful planning and management of this extractive activity is required, before, during and after the construction phase if long-term damage to the property's OUV is to be avoided. Observations by the mission of a (partially) restored borrow pit and discussions with NCA staff and consulting engineers suggest that work remains to be done towards development of suitable mitigation procedures for these potential impacts. There is a need to carry out initial surveys of environmental parameters, vegetation and possible archaeological interest prior to any site disturbance and make arrangements to ensure that ecological/archaeological restoration of disused sites can be carried out as fast and completely as possible at the end of the project.

**Fig. 7.** Two of the 'borrow pits' used to supply gravel for maintenance of the existing road. The site on the right is no longer active and has been (partially) restored, but illustrates the extent of the impact on the property's OUV. ©IUCN/Peter Howard.

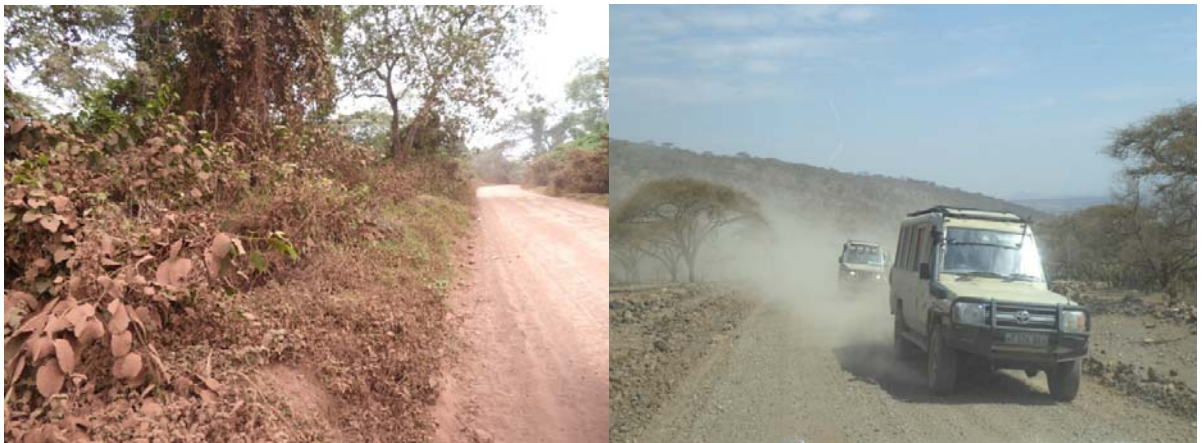
Present condition of the unsurfaced murram/gravel road through the NCA. Dust on road-side vegetation (Photo 3, left) and dust thrown up by passing vehicles (Photo 4, right). ©IUCN/Peter Howard.

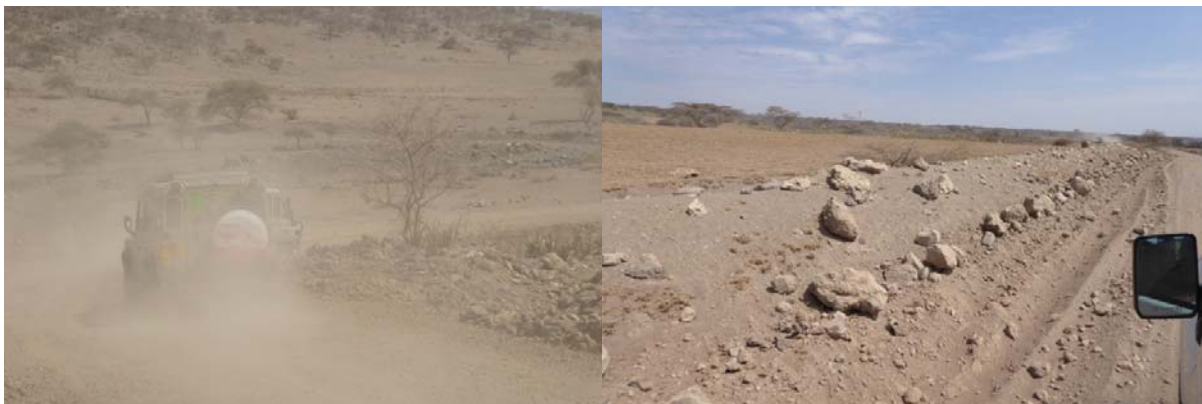
Present condition of the unsurfaced murram/gravel road through the NCA. Dusty travelling conditions (Photo 5, left) and unsightly waste material along the road verge (Photo 6, right). ©IUCN/Peter Howard.

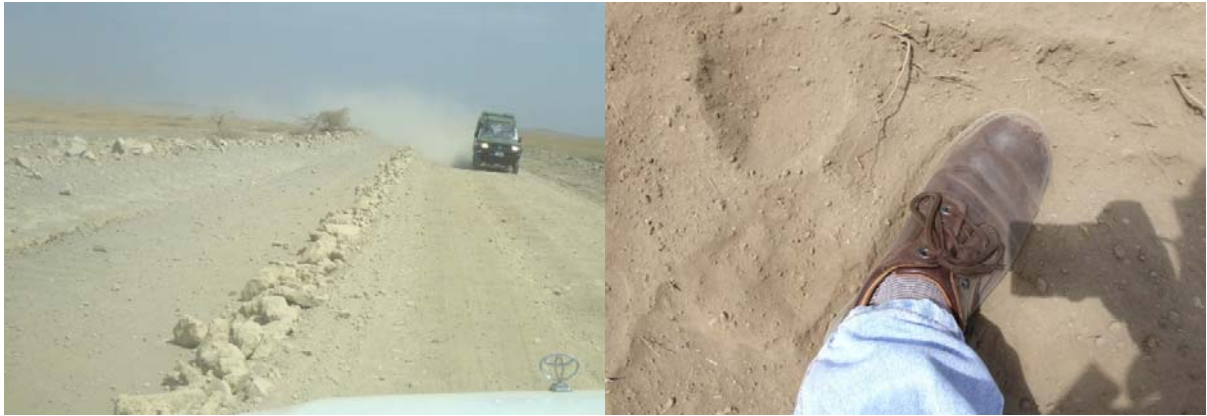
Present condition of the unsurfaced murram/gravel road through the NCA. Wide, bare, unsightly verge (Photo 7, left); roadside powdery dust illustrate the limited suitability of available material (Photo 8, right). ©IUCN/Peter Howard.

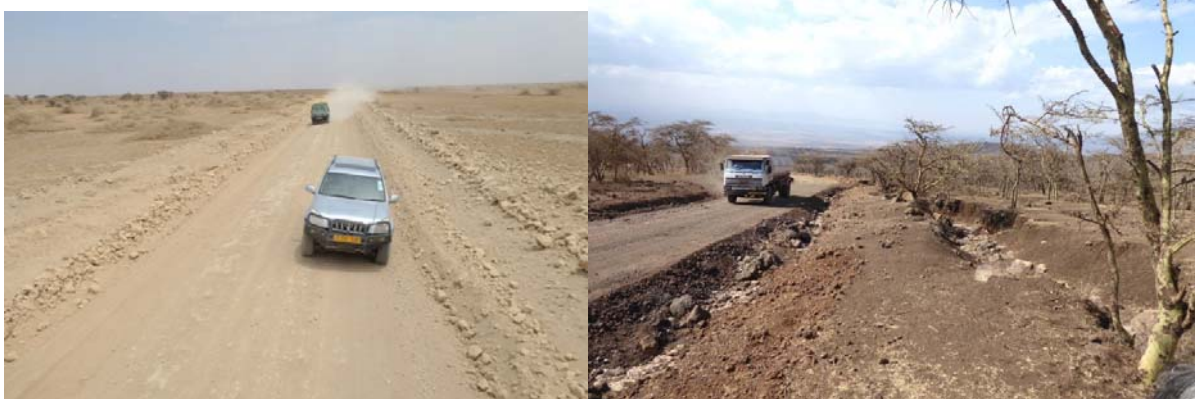
The 'visual width' of the road can be much greater than the designed carriageway width unless measures are taken at design and construction stages to minimise the apparent width of the impacts. This is observed at present in the section of road between approximately chainage +40.000 and +50.000 where catch water channels are located 1-2m away from the road itself, and at chainage +55.000 to Golini Gate where spoil cast off during the frequent regarding operations lies 1-2m either side of the carriageway.

Present condition of the unsurfaced murram/gravel road through the NCA. Wide, bare, unsightly verges near Golini (Photo 9, left); Gulley erosion scars at the road verge (Photo 10, right). ©IUCN/Peter Howard.

**R8.** As an interim measure prior to surface hardening NCCA should review the method of maintenance of the existing unpaved road, particularly in the section across the plains from +43.000 to Golini Gate. The review should include options such as enforcement of the speed limit of 50 km/h to reduce degradation, inclusion of geocell reinforcement to increase longevity of the gravel surface and management of the (unsightly) waste material at the road-side, not used within the surfacing.

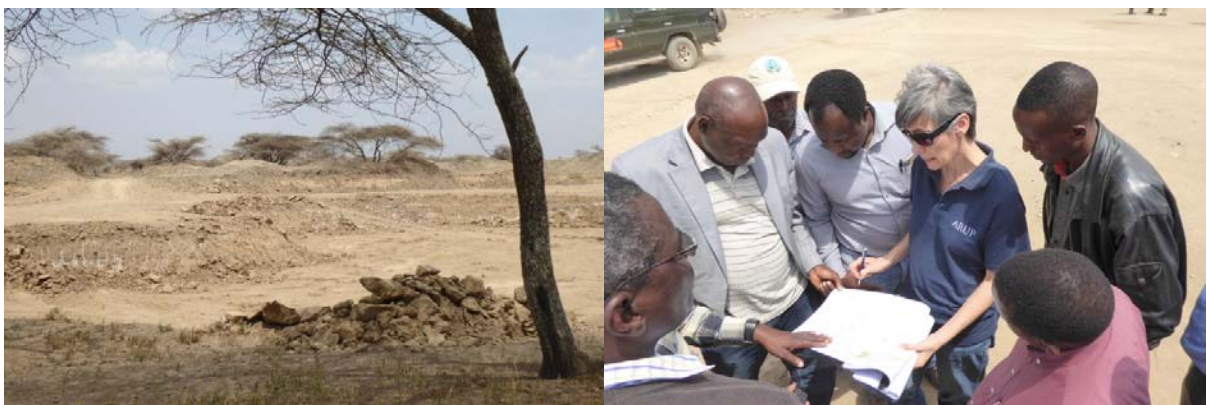
Borrow pit, illustrating the extent of environmental impacts related to present road maintenance requirements (Photo 11, left); team discussion during the field mission (Photo 12, right). ©IUCN/Peter Howard.

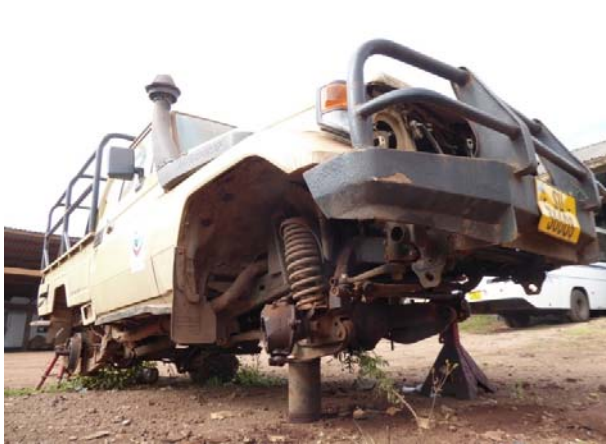
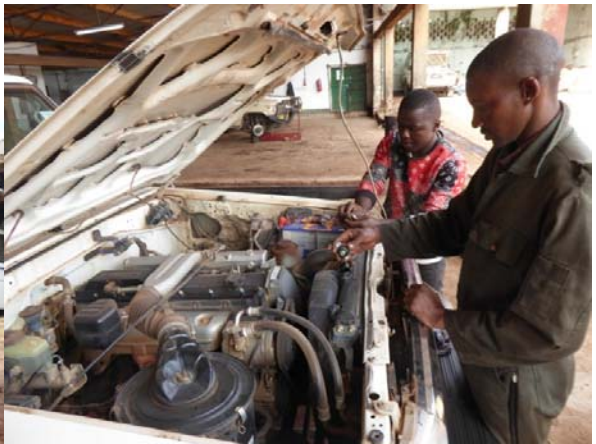
Existing road conditions result in frequent breakdowns and high vehicle maintenance costs (Photos 13 & 14). ©IUCN/Peter Howard.

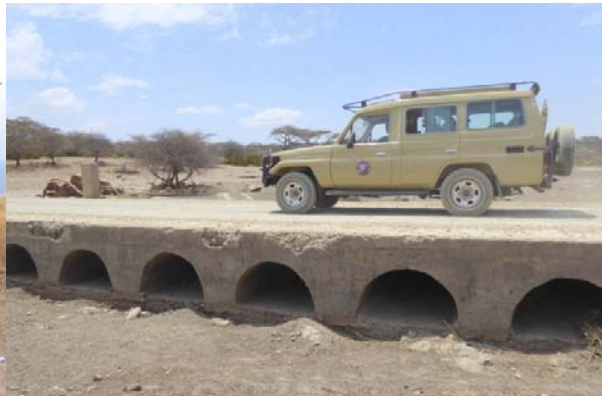
Roadside puncture repair (Photo 15, left); existing culvert subject to periodic flooding, will be replaced with a more substantial bridge to ensure 24-hour access for protection and management (Photo 16, right). ©IUCN/Peter Howard.
